Feasibility Study

BUDLONG POOL

198 Aqueduct Road
Cranston, Rhode Island

22 April 2022

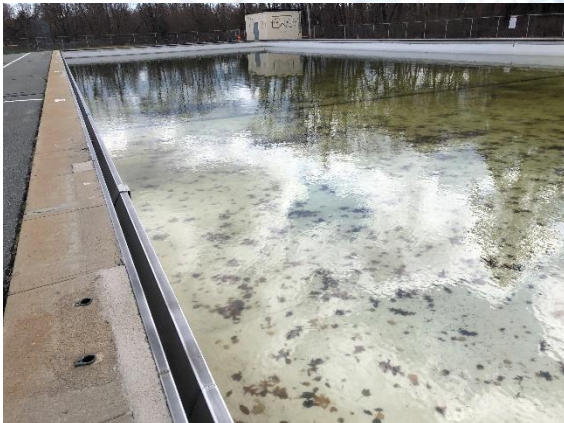
- ❖ The pool substrate has settled to the point where the casing has cracked to the point where the pool is constantly losing water. When in use, the pool must have a hose attached to the water supply at the pool house feeding a constant supply of water to the pool to ensure it stays full enough to safely host swimmers. A recent estimate has estimated the rate of water loss at 40-60 gallons per minute.

The pool itself will be comprehensively overhauled to correct all deficiencies and to address the structural failures of the pool shell and the substrate that is causing the pipe and valves to crack and leak. This will require the removal of the liner, excavation and removal of the unsuitable soils, installing new substrate materials, and reinstallation of the new pool basin with new drains, and the completion of the interior pool finish / liner.

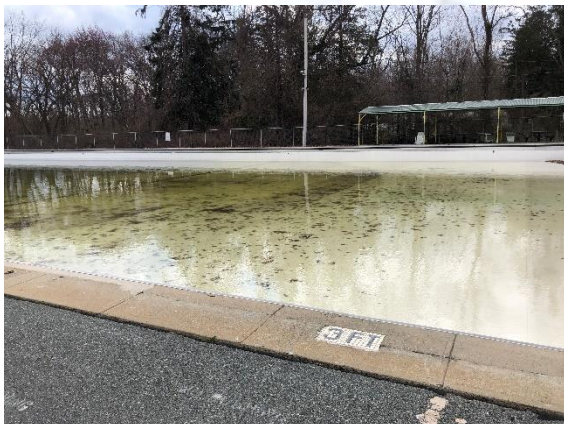
- ❖ The pool, when closed, is not drained of its water. The low water table of the later summer / early fall months receives the water from the pool and the numerous cracks in the drains which eventually drains the pool of its water. This leaking water adds to the areas water table.

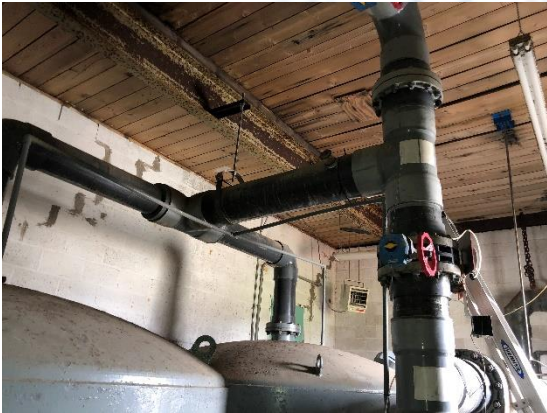
❖ The sand filter is an older system and requires a significant overhaul and replacement of filtration media to keep the system in operation at great cost to the City. The backwash of the filters (to establish proper suction in the system) discharges outside the filter building and discharges the pool water in the system directly into the area adjacent to the stream connecting the site to the Blackamore Pond.
