August 17, 2023

From: Mark Mariano, PE, CPO  
Team Leader  
Weston & Sampson Engineers Inc.  
85 Devonshire Street  
Boston, MA 02109

### Memorandum – Budlong Park Pool, Cranston RI – Existing Conditions

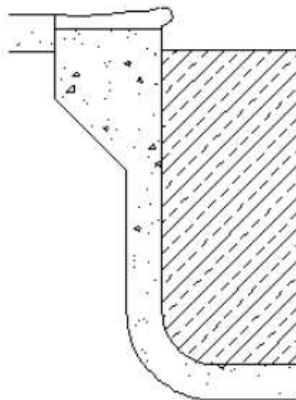
***Figure 4.5.12.1: Plumb Pool Walls: Cross-Section***

14. On the deep end pool wall there is a wall obstruction. It appears to be part of the pool as the pool was liner-ed over it. This a violation of MAHC [4.5.12.4](#) – No Protrusions, Extensions, Means of Entanglement, or Obstruction. This requires walls to be within +/- 3 Degrees in vertical tolerance. There are areas of the shallow that seem to be more than 3 % of tolerance.

Plumb within a +/- 3 degree tolerance.
