Feasibility Study

BUDLONG POOL

198 Aqueduct Road
Cranston, Rhode Island

22 April 2022

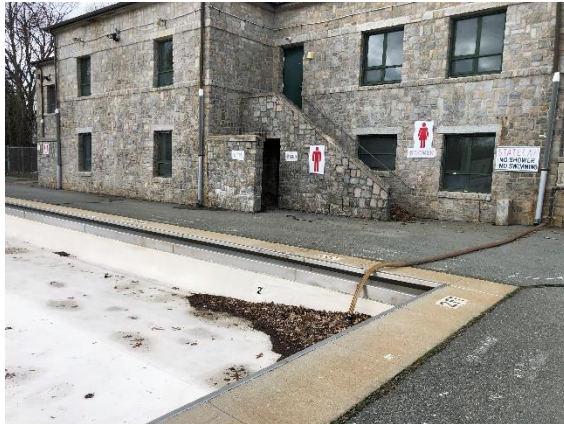
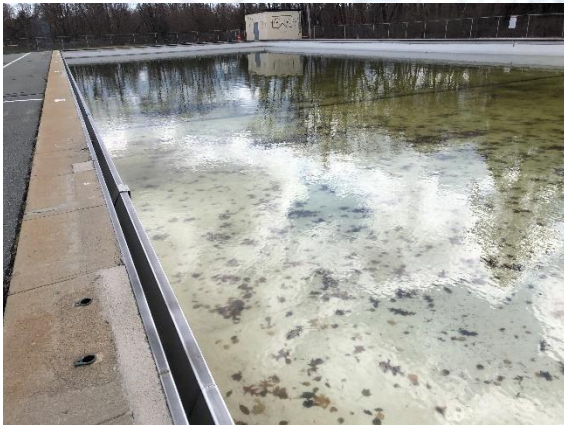
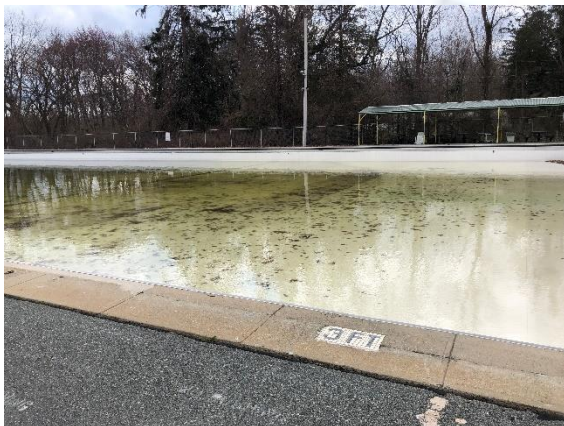
The pool, while being a landmark to the City of Cranston as well as being one of the largest outdoor pools in the nation, is facing several performance issues that are severe enough for the City to consider the pool is close to the end of its serviceable life. The issues include, but are limited to, the following points:

- ❖ The pool substrate has settled to the point where the casing has cracked to the point where the pool is constantly losing water. When in use, the pool must have a hose attached to the water supply at the pool house feeding a constant supply of water to the pool to ensure it stays full enough to safely host swimmers. A recent estimate has estimated the rate of water loss at 40-60 gallons per minute.

The pool itself will be comprehensively overhauled to correct all deficiencies and to address the structural failures of the pool shell and the substrate that is causing the pipe and valves to crack and leak. This will require the removal of the liner, excavation and removal of the unsuitable soils, installing new substrate materials, and reinstallation of the new pool basin with new drains, and the completion of the interior pool finish / liner.

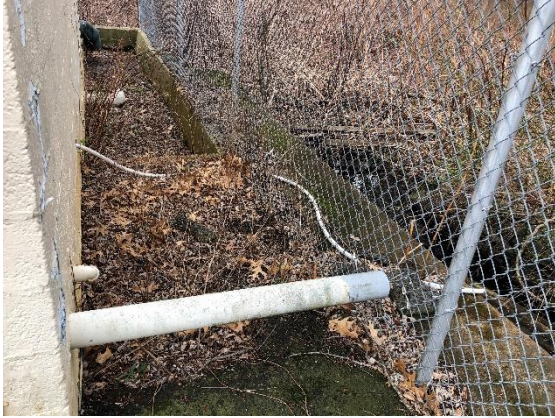
- ❖ During the spring months, the water table of the area is elevated due to snow and ice melting in the soil along with the additional water flow from Blackamore Pond and elevated rain fall. The system works in reverse with regards to the above mentioned leaking and the raised water table actually adds untreated water back into the pool. The water seen in the pictures included is groundwater and not rain/snow melt.

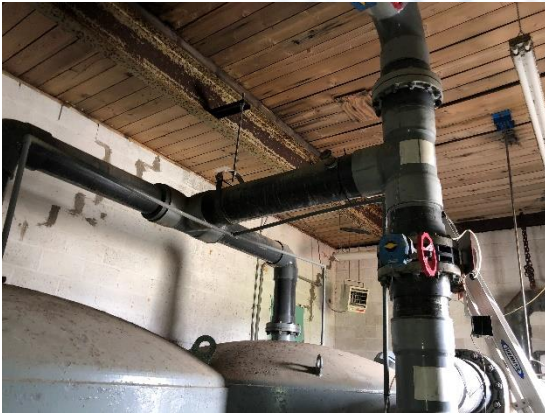
❖ Pool equipment must comply with the Title XIV – Pool and Spa Safety Act (aka the Virginia Graeme Baker Pool and Safety Act) and the RI State Building Code. Also known as the VGB guidelines, these rules cover the size and configurations of mechanicals under the surface of the water to prevent suction entrapment to swimmers. The pool mechanicals have not been updated to meet these requirements and present a potential hazard to swimmers.
