Feasibility Study

BUDLONG POOL

198 Aqueduct Road
Cranston, Rhode Island

22 April 2022

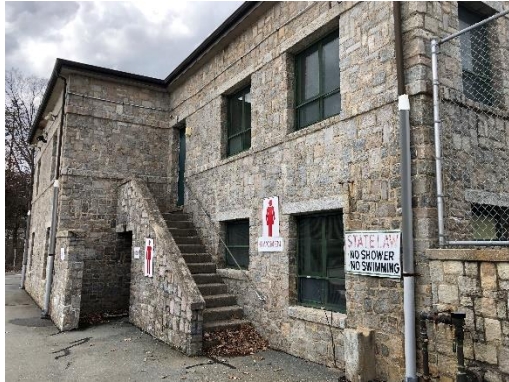
Located along the north end of the site along Aqueduct Drive, the existing pool house that supports the operations of the pool is a stone veneer structure that was built almost 80 years ago and is in a critical state due to its age and programmed spaces.

- ❖ The existing roof is compromised in several locations and evidence of active leaks is present throughout the upper floor ceilings.

- ❖ A roof drain has been leaking for an extended period of time and has saturated the structural slab separating the two floors. This is evidenced through a partial ceiling collapse in the lower level mechanical room. The structural slab has spalled its lower layer of concrete and one can view the exposed rusted and deteriorated steel reinforcing bars. These bars have mostly rusted away and resulting slab is starting to become compromised structurally.

- ❖ The exterior chimney that serves the communal meeting space on the upper level is sinking from subsidence of the soils. This has resulted in the entire stone chimney structure to pull away from the building exterior by as much as six inches. The risk of collapse is so evident that at some point a bent steel brace was installed around the upper portion of the chimney and anchored into the surrounding stone in an attempt to prevent full collapse. The gap created from the chimney pulling away has been filled with grout that has since cracked and become loose; thereby indicating that water is still infiltrating and that the chimney has not been fully stabilized.

Upgrading the existing building will focus on rectifying the envelope issues, upgrading the restrooms and locker rooms with the intent of increasing their capacity, updating the accessibility issues, repairing the roof and structural slab, and properly identifying and abating the hazardous materials on site.
